Manhole Inspection Summary

Manhole # S45G__010MH

Insp Date: **7/15/08 9:03 AM**

Location Address: **236 s durham st**

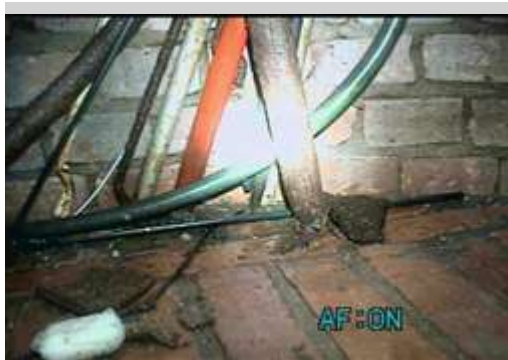
misc

bench debris

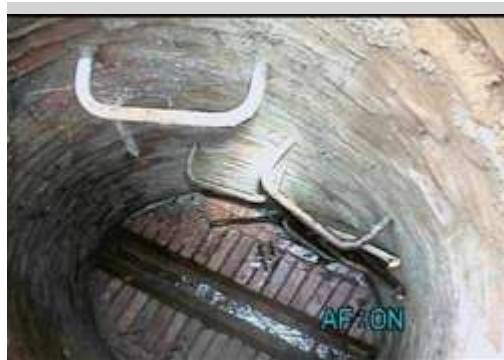
Defect 2

Steps Count: **4** Missing: **0** ☒ **Corroded**

steps

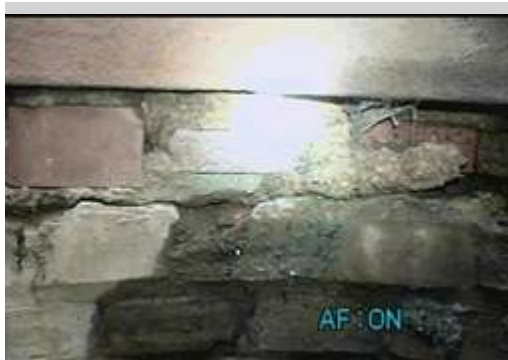
Defect 1

Condition: ☐ Sound ☒ **Cracked** ☐ Root Intrusion ☒ **Loose Brick** ☒ **Deteriorated**

Infiltration: ☐ None ☐ Joint ☒ **Cracks** ☐ Mortar ☐ Roots ☐ Wall

chimney cracked, loose bricks, & deteriorated with signs of infiltration from cracks

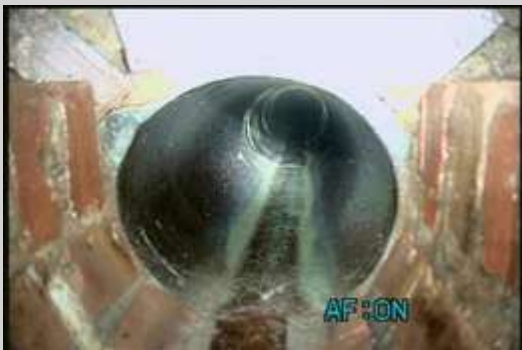
12 O'Clock Outflow

8 in. Circular Gravity Sewer
Pipe Out @ 12 O'Clock

Infiltration: **None** Pipe Seal Cond: **Unknown**

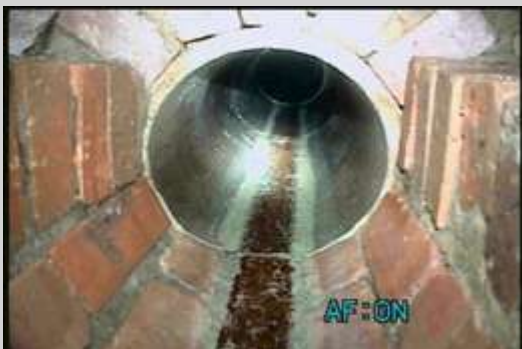
6 O'Clock Inflow

8 in. Circular Gravity Sewer
Pipe In @ 6 O'Clock

Infiltration: **None** Pipe Seal Cond: **Unknown**
